**Flood Control Project Maintenance  
Levee Inspections**  
**LMA District Cover Sheet**  
**Spring 2020 Levee Inspection Results**

**American River Flood Control District**

**Spring 2020 Levee Inspection Results**

Waterway			Bank	Unit Miles
Unit No. 01 Arcade Creek			Left	2.08
	Spring (March - May)	Summer (June - August)	(September - November) Fall	Winter (December - February)
Unit Maintenance Rating (Fall Only)				
Date of Inspection	3/25/2020 - 3/25/2020			
DWR Inspector	Luz Dial			
Accompanied By	Gilbert Gutierrez ARFCD

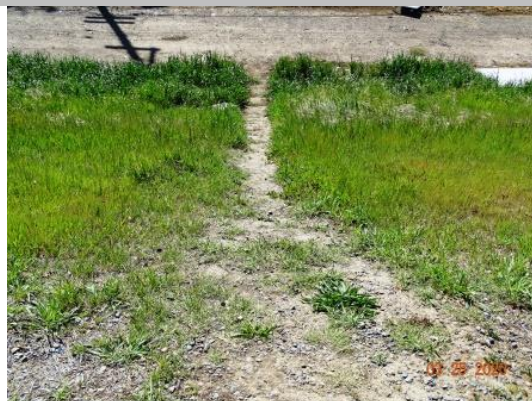
Photo 1 of 1 : SP\_2020\_NA0001\_51\_48\_20200326\_00085.jpg

LM Start	0.48	Rating **	M	Issue No.	48
LM End	0.48	Issue Type +	Ma	Location *	LS
Category	Earthen Levee			GPS Latitude/Longitude	
				Start	End
Item	Slope Stability			38.623177 °	38.623177 °
				-121.460360 °	-121.460360 °
DWR ID	DWR_NA0001_01_s_2020_48				
Comment Code					
S2 : Repair the levee slope damaged by foot traffic and prevent access where possible.					
Inspector Comment					
Steps are cut into the levee.

View of steps dug into the landside levee slope. Spring 2020

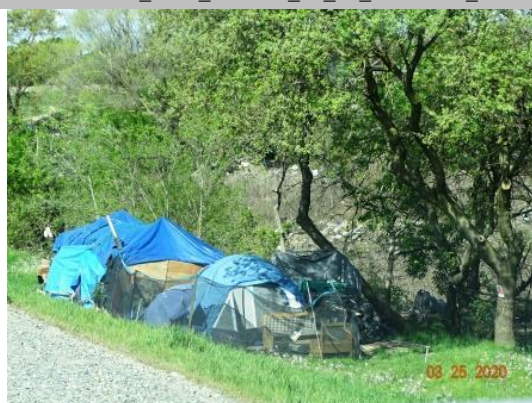
Photo 1 of 1 : SP\_2020\_NA0001\_51\_44\_20200326\_00087.jpg

LM Start	0.50	Rating **	M	Issue No.	44
LM End	0.50	Issue Type +	En	Location *	WS
Category	Earthen Levee			GPS Latitude/Longitude	
				Start	End
Item	Encroachments			38.623355 °	38.623355 °
				-121.460037 °	-121.460037 °
DWR ID	DWR_NA0001_01_s_2020_44				
Comment Code					
DE : Debris					
Inspector Comment					
Two tents reside at the waterside toe.

View of two tents at the waterside toe. Spring 2020

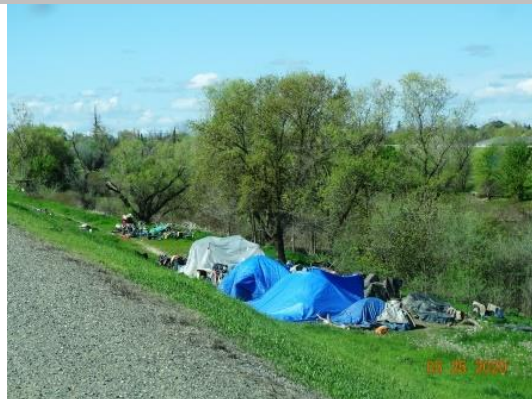
Photo 1 of 1 : SP\_2020\_NA0001\_51\_42\_20200326\_00086.jpg

LM Start	0.56	Rating **	M	Issue No.	42
LM End	0.63	Issue Type +	En	Location *	WS
Category	Earthen Levee			GPS Latitude/Longitude	
				Start	End
Item	Encroachments			38.623612 °	38.623698 °
				-121.459008 °	-121.457742 °
DWR ID	DWR_NA0001_01_s_2020_42				
Comment Code					
DE : Debris					
Inspector Comment					
Camps reside on the waterside toe.

View of camps at the waterside toe. Spring 2020

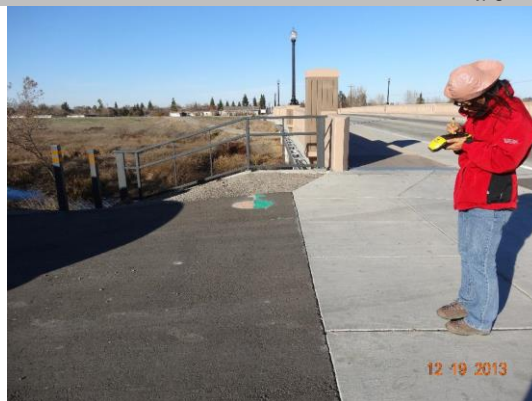
Photo 1 of 1 : UCIP\_SP\_2020\_31169\_57044.jpg

LM Start	0.66	Rating **	M	Issue No.	184
LM End	0.66	Issue Type +	En	Location *	
Category	Supplemental			GPS Latitude/Longitude	
				Start	End
Item	DWR UCIP Field Study			38.623668 °	38.623668 °
				-121.457156 °	-121.457156 °
DWR ID	24800				
Comment Code					
Inspector Comment					
DS_ID:24800 FS_ID:31169 EP_NO: N/A Repair Type: Non-Urgent Crossing Status: Found UCIP Comments: Need to coordinate with the City of Sacramento to determine if structure (assumed indicated by green/orange symbol) crosses levee or symbol is referencing bridge. FIELD_STRUCT_DESC: Indicator of crossing found on waterward side edge. Symbol for Flood Control Structure (green/orange circle) was found during field inspection 12/19/13, symbol matches flood control structures that the City of Sacramento inspects. FS Date: 12/19/2013

Indicator of crossing found on waterward side edge. Symbol is a Flood Control Structure (green/orange circle).

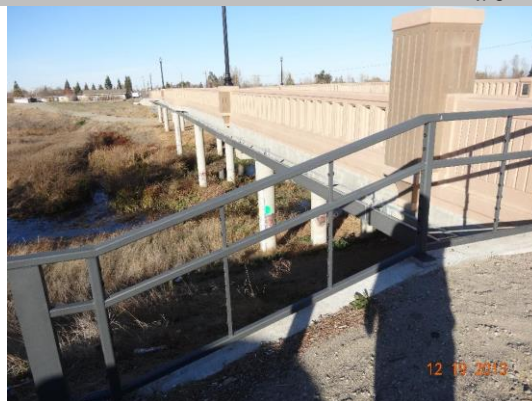
Photo 1 of 3 : UCIP\_SP\_2020\_53488\_57042.jpg

DS\_ID:24266  
FS\_ID:53488  
EP\_NO: 18641-1  
Repair Type: Non-Urgent  
Crossing Status: Found  
UCIP Comments: 07/18/2018 Crossing appears to be the same as last time. Markers have not been placed. PG&E provided supporting documentation that this crossing is in good shape. Plus it is getting raised to the 200-year water surface elevation. PG&E records for this distribution main indicate that there were no leaks found on the 06/2017 leak survey and the pipeline is operating correctly according to the 12/2016 CP inspection. Crossing is downgraded to "Non-Urgent" until the gas line is raised to the 200-year level. (A. McDonald - DWR UCIP)8/11/2016 Markers still missing. LMA representatives, Tim Kerr and Richard Marck, provided permit for 4-inch PG&E gasline to be raised to 200-year water surface elevation. Pipe will be modified on both the right and left bank. Elevation through the levee will need to be modified once pipe is raised through levee. (DWR UCIP - omagana)12/19/2013 no markers visible on waterward or landward side indicating this is a gas line--need to contact owner to determine if this crossing is gas line. (DWR UCIP - omagana)

View of WS--pipe suspended along downstream face of bridge.

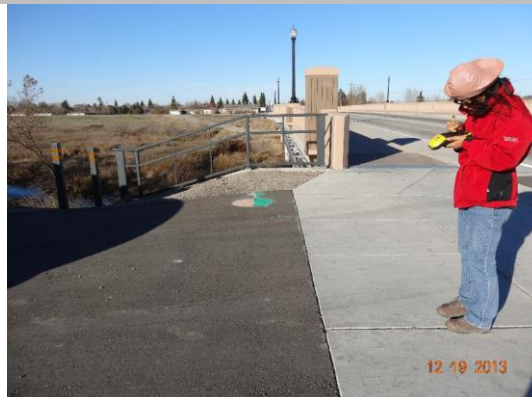
Photo 2 of 3 : UCIP\_SP\_2020\_53488\_57041.jpg

Paint on paved levee indicates crossing could be a storm drain.

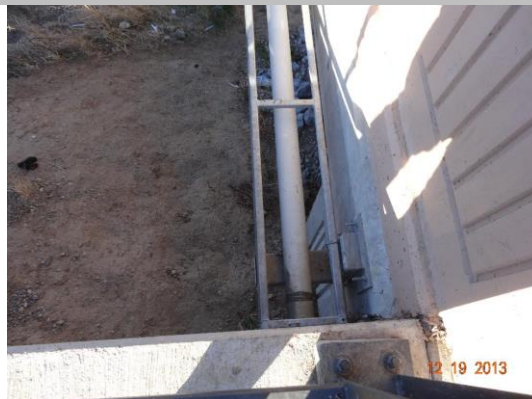
Photo 3 of 3 : UCIP\_SP\_2020\_53488\_57040.jpg

View of pipe suspended over waterway.

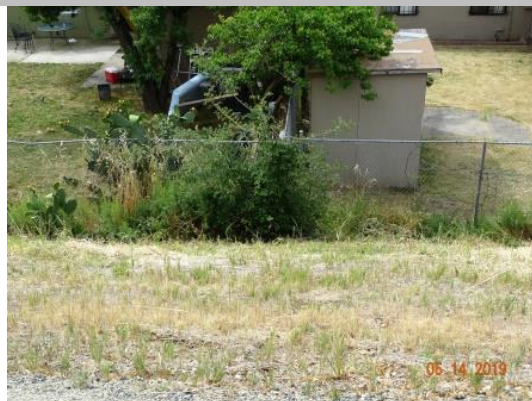
Photo 1 of 1 : SP\_2020\_NA0001\_51\_81\_20200302\_00043.jpg

LM Start	0.74	Rating **	M	Issue No.	81
LM End	0.74	Issue Type +	En	Location *	LS
Category	Earthen Levee			GPS Latitude/Longitude	
				Start	End
Item	Vegetation			38.623932 °	38.623932 °
				-121.455652 °	-121.455652 °
DWR ID	DWR_NA0001_01_s_ 2019_81				
Comment Code					
V6 : Landscaping					
Inspector Comment					
Remove cactus.

View looking south at cactus on levee toe. Spring 2019

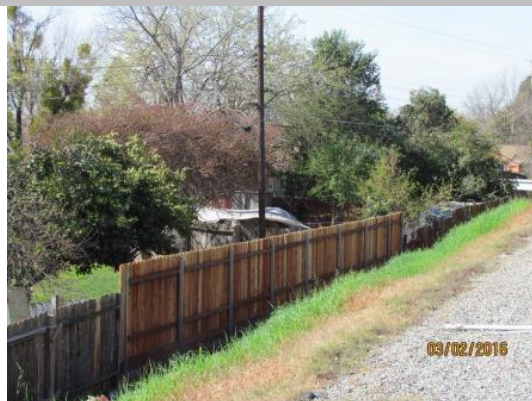
Photo 1 of 1 : SP\_2020\_NA0001\_51\_21\_20200302\_00016.jpg

LM Start	1.17	Rating **	U	Issue No.	21
LM End	1.17	Issue Type +	En	Location *	LS
Category	Earthen Levee			GPS Latitude/Longitude	
				Start	End
Item	Encroachments			38.624906 °	38.624906 °
				-121.448259 °	-121.448259 °
DWR ID	DWR_NA0001_01_s_2012_21				
Comment Code					
FE : Fence					
Inspector Comment					
A dog-eared wooden fence is built against the levee slope.

View of the fence at the landside levee toe. Spring 2016

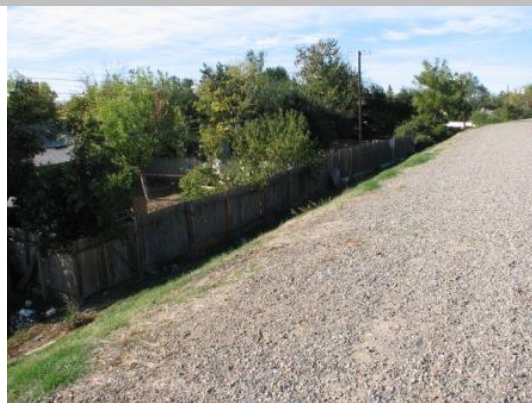
Photo 1 of 1 : SP\_2020\_NA0001\_51\_20\_20200302\_00015.jpg

LM Start	1.18	Rating **	U	Issue No.	20
LM End	1.18	Issue Type +	En	Location *	LS
Category	Earthen Levee			GPS Latitude/Longitude	
				Start	End
Item	Encroachments			38.624900 °	38.624900 °
				-121.448037 °	-121.448037 °
DWR ID	DWR_NA0001_01_s_2012_20				
Comment Code					
FE : Fence					
Inspector Comment					
A dog-eared wooden fence is built against the levee slope.

Photo of solid fences built against the levee slope.

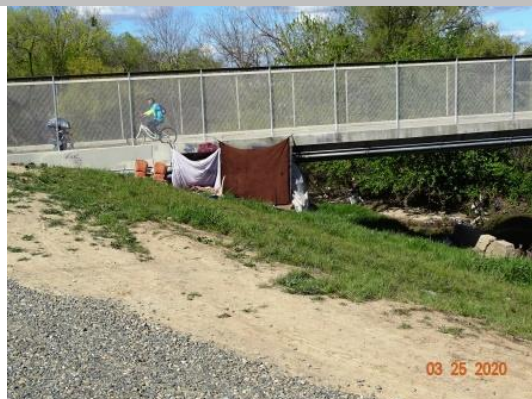
Photo 1 of 1 : SP\_2020\_NA0001\_51\_84\_20200326\_00082.jpg

LM Start	1.22	Rating **	M	Issue No.	84
LM End	1.22	Issue Type +	En	Location *	WS
Category	Earthen Levee			GPS Latitude/Longitude	
				Start	End
Item	Encroachments			38.625082 °	38.625082 °
				-121.447368 °	-121.447368 °
DWR ID	DWR_NA0001_01_s_2020_84				
Comment Code					
DE : Debris					
Inspector Comment					
A camp is set up under the pedestrian bridge with garbage on the crown.

View of a camp set up on the waterside slope underneath the pedestrian bridge. Spring 2020

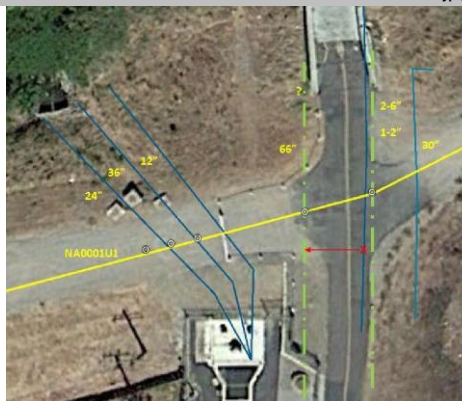
Photo 1 of 1 : UCIP\_SP\_2020\_31178\_57059.jpg

Comment Code						
Inspector Comment						
DS_ID:24248 FS_ID:31178 EP_NO: 14575 Repair Type: Non-Urgent Crossing Status: Not Found UCIP Comments: 12/19/2013 Crossing is present in the layer provided by the City of Sacramento, however this crossing was not found in the field. Need to determine status of crossing. If crossing is no longer used, owner will need to coordinate with Central Valley Flood Protection Board to comply with Title 23. FIELD_STRUCT_DESC: 30-inch concrete encased steel water main through the levee, 4.5 feet below the crown. Steel cutoff wall around pipe at center of levee. (30-inch pipe authorized under Permit No. 14575, 1988 - City of Sacramento; 30-inch is scheduled to be cut and replaced under Permit No. 14575-1, 2016 - City of Sacramento) [Additional Reference(s): DWR Levee Log, 2002] FS Date: 12/19/2013

Alignment indicated in blue is approximate locations for pipes that cross levee. Alignment information was obtained from the City of Sacramento.

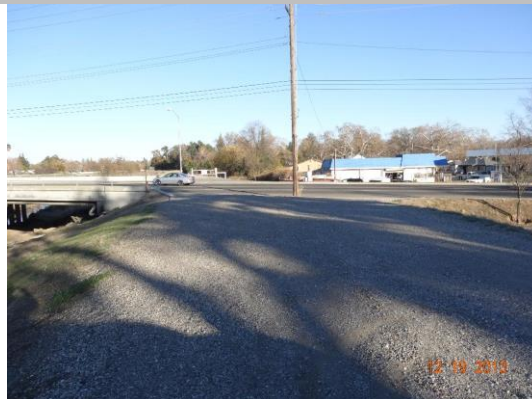
Photo 1 of 3 : UCIP\_SP\_2020\_30085\_55489.jpg

LM Start:	1.28	Rating **	M	Issue No.	187
LM End	1.28	Issue Type +	En	Location *	
Category	Supplemental			GPS Latitude/Longitude	
				Start	End
Item	DWR UCIP Field Study			38.625500 °	38.625500 °
				-121.446390 °	-121.446390 °
DWR ID	24576				
Comment Code					
Inspector Comment					
DS_ID:24576 FS_ID:30085 EP_NO: N/A Repair Type: Non-Urgent Crossing Status: Indicator Found UCIP Comments: Unable to confirm location--will need to coordinate with owner to determine if crossing is still active and determine location. FIELD_STRUCT_DESC: 1 of 3: 16-inch pipe through the levee, 8 feet below the crown. Floodgates within the levee across the channel, installed under Permit No. 14480 (1986). [Additional Reference(s): DWR Levee Log, 2002] FS Date: 12/19/2013

Overview of levee crown at crossing.

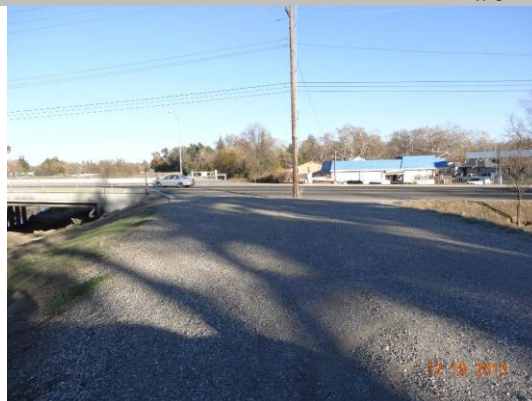
Photo 1 of 3 : UCIP\_SP\_2020\_29732\_54976.jpg

DS\_ID:24577  
 FS\_ID:29732  
 EP\_NO: N/A  
 Repair Type: Non-Urgent  
 Crossing Status: Indicator Found  
 UCIP Comments: Unable to confirm location--will need to coordinate with owner to determine if crossing is still active and determine location.  
 FIELD\_STRUCT\_DESC: 2 of 3: 6-inch pipe through the levee, 8 feet below the crown. Flap gate on the waterside (WS) end. Floodgates within the levee across the channel, installed under Permit No. 14480 (1986). [Additional Reference(s): DWR Levee Log, 2002]  
 FS Date: 12/19/2013

Overview of levee crown.

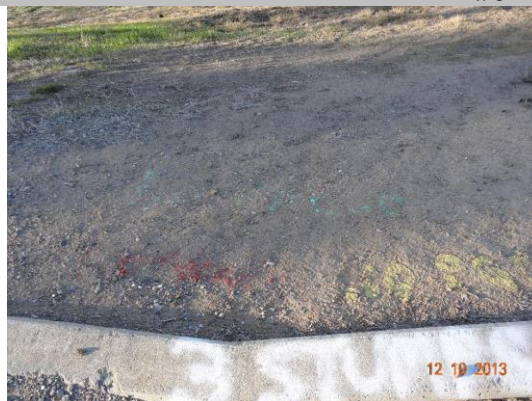
Photo 2 of 3 : UCIP\_SP\_2020\_29732\_54975.jpg

Underground service alert (USA) paint markers visible on waterward shoulder--unable to confirm type of crossings.

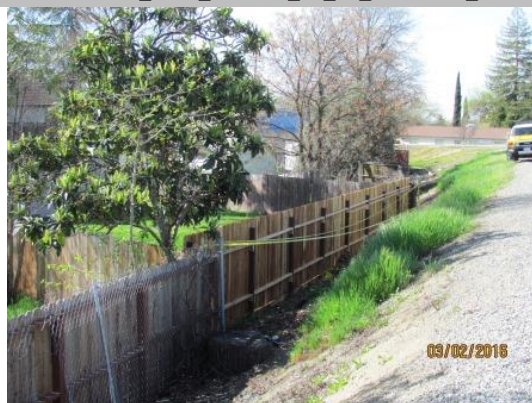
Photo 1 of 1 : SP\_2020\_NA0001\_51\_73\_20200302\_00041.jpg

LM Start	1.33	Rating **	U	Issue No.	73
LM End	1.33	Issue Type +	En	Location *	LS
Category	Earthen Levee			GPS Latitude/Longitude	
				Start	End
Item	Encroachments			38.625869 °	38.625869 °
				-121.445477 °	-121.445477 °
DWR ID	DWR_NA0001_01_f_2015_73				
Comment Code					
FE : Fence					
Inspector Comment					
A fence is at the landside toe.

View of the fence at the landside levee toe. Spring 2016

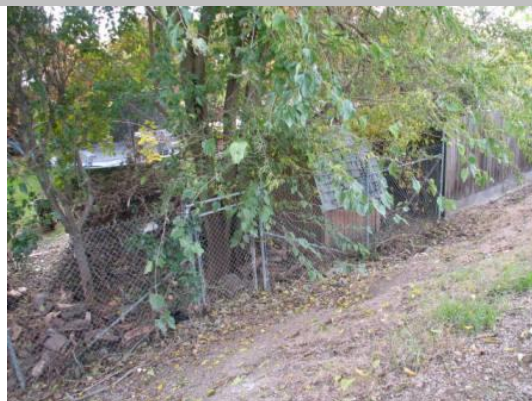
Photo 1 of 1 : SP\_2020\_NA0001\_51\_38\_20200302\_00025.jpg

LM Start	1.40	Rating **	M	Issue No.	38
LM End	1.40	Issue Type +	En	Location *	LS
Category	Earthen Levee			GPS Latitude/Longitude	
				Start	End
Item	Encroachments			38.626210 °	38.626210 °
				-121.444320 °	-121.444320 °
DWR ID	DWR_NA0001_01_s_2012_38				
Comment Code					
BU : Building					
Inspector Comment					
A small wooden storage shed and firewood are placed along the chain link fence within 10-ft of the levee toe.

11/17/2011 Shed and firewood can be seen through the chainlink fence.

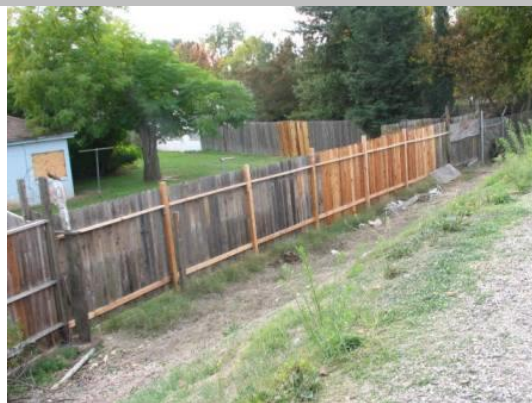
Photo 1 of 1 : SP\_2020\_NA0001\_51\_13\_20200302\_00010.jpg

LM Start	1.40	Rating **	U	Issue No.	13
LM End	1.40	Issue Type +	En	Location *	LS
Category	Earthen Levee			GPS Latitude/Longitude	
				Start	End
Item	Encroachments			38.626155 °	38.626155 °
				-121.444250 °	-121.444250 °
DWR ID	DWR_NA0001_01_f _ 2019_13				
Comment Code					
FE : Fence					
Inspector Comment					
A wooden fence with barbed wire is built within 10-ft of the levee toe.

11/17/2011 New wooden privacy fence built within 15' of the levee toe.

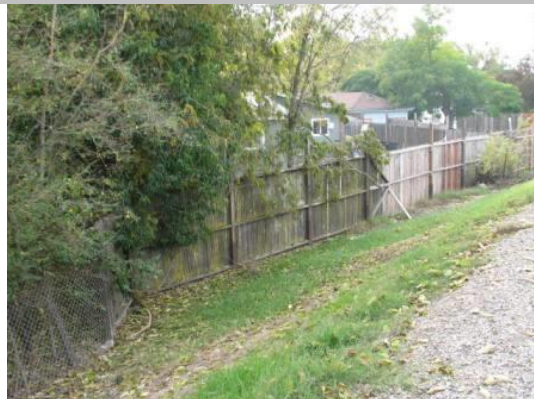
Photo 1 of 1 : SP\_2020\_NA0001\_51\_12\_20200302\_00009.jpg

LM Start	1.41	Rating **	M	Issue No.	12
LM End	1.41	Issue Type +	En	Location *	LS
Category	Earthen Levee			GPS Latitude/Longitude	
				Start	End
Item	Encroachments			38.626212 °	38.626212 °
				-121.444082 °	-121.444082 °
DWR ID	DWR_NA0001_01_s_2012_12				
Comment Code					
FE : Fence					
Inspector Comment					
A wooden fence is built near the levee slope.

11/17/2011 Wooden privacy fence built within 15' of the levee toe.

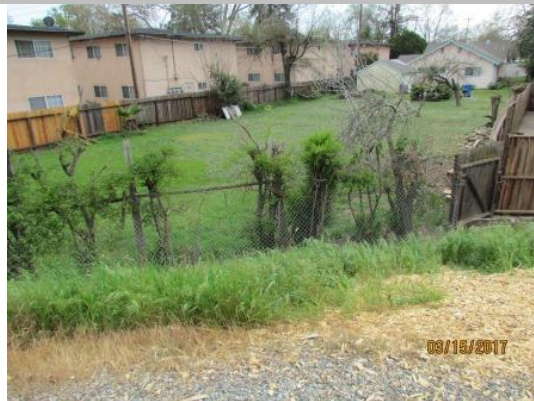
Photo 1 of 1 : SP\_2020\_NA0001\_51\_177\_20200302\_00048.jpg

LM Start	1.42	Rating **	M	Issue No.	177
LM End	1.42	Issue Type +	En	Location *	LS
Category	Earthen Levee			GPS Latitude/Longitude	
				Start	End
Item	Vegetation			38.626388 °	38.626388 °
				-121.443910 °	-121.443910 °
DWR ID	DWR_NA0001_01_s_2012_177				
Comment Code					
V6 : Landscaping					
Inspector Comment

Another view of the vegetation at levee toe. Spring 2017.

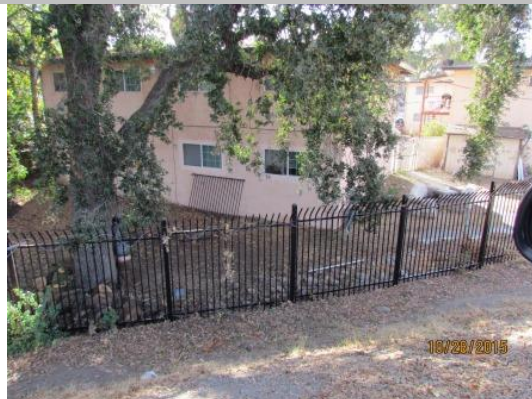
Photo 1 of 1 : SP\_2020\_NA0001\_51\_70\_20200302\_00040.jpg

LM Start	1.44	Rating **	U	Issue No.	70
LM End	1.44	Issue Type +	En	Location *	LS
Category	Earthen Levee			GPS Latitude/Longitude	
				Start	End
Item	Encroachments			38.626589 °	38.626589 °
				-121.443640 °	-121.443640 °
DWR ID	DWR_NA0001_01_f_2015_70				
Comment Code					
FE : Fence					
Inspector Comment					
A wrought iron fence at the LS toe blocks access.

View of the fence at the landside levee toe. Fall 2015

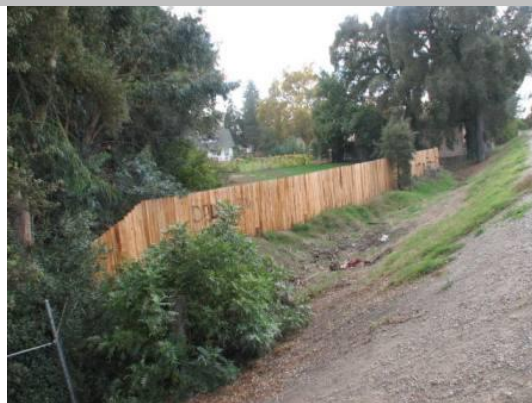
Photo 1 of 1 : SP\_2020\_NA0001\_51\_176\_20200302\_00047.jpg

LM Start	1.47	Rating **	U	Issue No.	176
LM End	1.47	Issue Type +	En	Location *	LS
Category	Earthen Levee			GPS Latitude/Longitude	
				Start	End
Item	Encroachments			38.626881 °	38.626881 °
				-121.443253 °	-121.443253 °
DWR ID	DWR_NA0001_01_s_2012_176				
Comment Code					
FE : Fence					
Inspector Comment					
A wooden privacy fence is within 10' of the levee toe.

11/17/2011 Wooden privacy fence built within 15' of the levee toe.

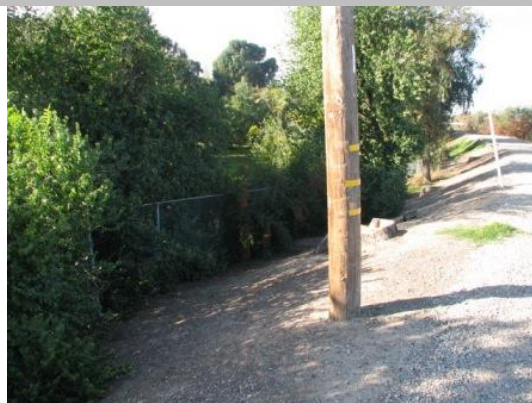
Photo 1 of 1 : SP\_2020\_NA0001\_51\_35\_20200302\_00024.jpg

LM Start	1.53	Rating **	M	Issue No.	35
LM End	1.53	Issue Type +	En	Location *	LS
Category	Earthen Levee			GPS Latitude/Longitude	
				Start	End
Item	Vegetation			38.627255 °	38.627255 °
				-121.442402 °	-121.442402 °
DWR ID	DWR_NA0001_01_s_2012_35				
Comment Code					
V6 : Landscaping					
Inspector Comment					
Bushes and trees along the chain link fence block access and visibility.

Fall 2009 photo:Vegetation obstructing visibility near levee slope.

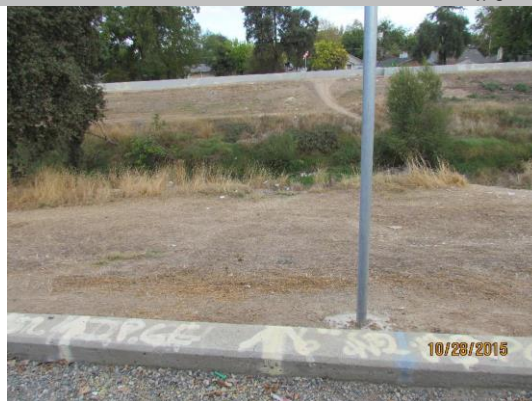
Photo 1 of 3 : UCIP\_SP\_2020\_52671\_74731.jpg

Markers installed on both levees in 2015.

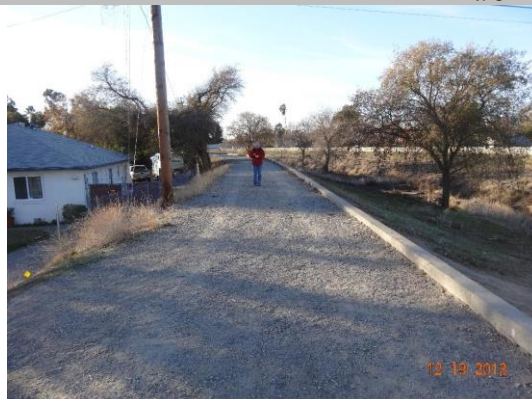
Photo 2 of 3 : UCIP\_SP\_2020\_52671\_57072.jpg

Overview of area near crossing. Inspector is standing where crossing goes through levee.

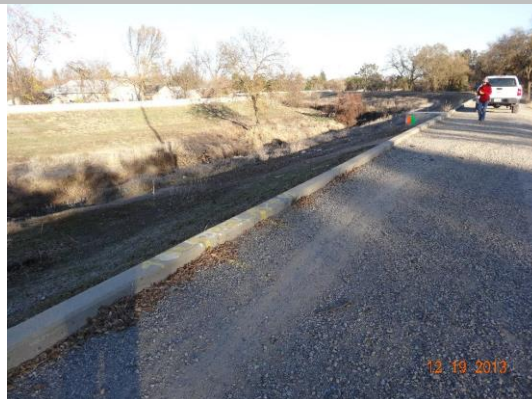
Photo 3 of 3 : UCIP\_SP\_2020\_52671\_57071.jpg

View of waterward side.

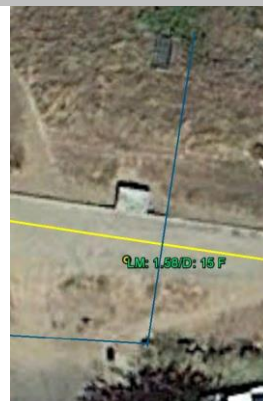
Photo 1 of 3 : UCIP\_SP\_2020\_31182\_57075.jpg

Comment Code					
Inspector Comment					
DS_ID:24255 FS_ID:31182 EP_NO: N/A Repair Type: Non-Urgent Crossing Status: Found UCIP Comments: 08/16/2017 DWR Deferred Maintenance Project (DMP), Vince Rodriguez, forwarded email received from Tim Kerr, General Manager of American River Flood Control District (ARFCD) with file "DWR Eligible Pipes Found in ARFCD" from ARFCD that shows the ownership and location of the pipes Tim Kerr investigated. Owner of this crossing is identified as the City of Sacramento, ARFCD Staff Notes indicate Arcade Ck at Belden St. (DWR UCIP - O. Magana) 06/06/2017 Received documentation from the City of Sacramento indicating that this crossing was internally inspected on 11/26/2013, PACP Sewer Report was provided. No additional information was received from the City of Sacramento. Need to request evaluation of pipe (integrity of pipe section through the levee) and clarify pipe size. (DWR UCIP – O. Magana) 01/29/14 approximate alignment of crossings was provided by the City of Sacramento for known crossings through levee. Unable to confirm last inspection. Also City records indicate 24-inch CMP not 15-inch--need to clarify with owner. Crossing is operational. FIELD_STRUCT_DESC: 15-inch drainage pipe of unknown material (City records indicate a 24-inch reinforced concrete pipe (RCP) at this location) through the levee, 8.5 feet below the crown. Flap gate on the waterside (WS) end. (no permit was found authorizing this pipe - the City of Sacramento is the owner of this pipe) [Additional Reference(s): DWR Levee Log, 2002] FS Date: 12/19/2013

Alignment in blue is an estimate of pipe alignment provided by the City of Sacramento. The symbol at LM 1.58 is field confirmed location.

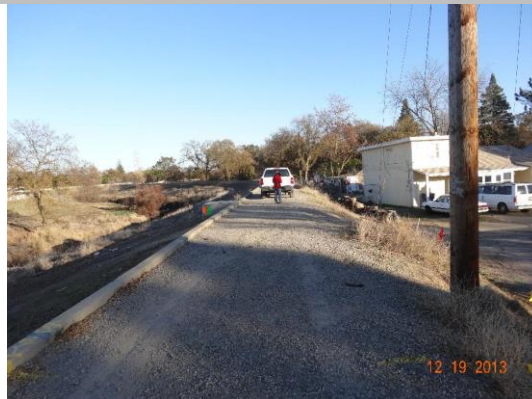
Photo 2 of 3 : UCIP\_SP\_2020\_31182\_57076.jpg

Overview of levee at crossing.

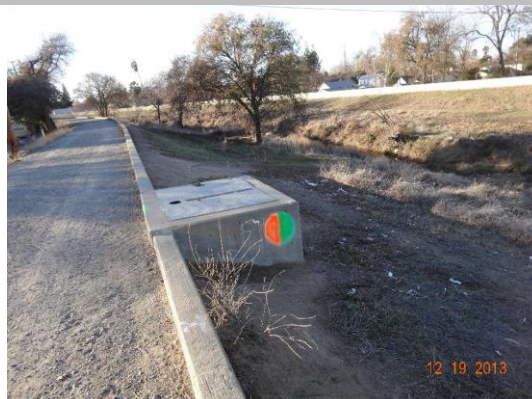
Photo 3 of 3 : UCIP\_SP\_2020\_31182\_57077.jpg

View of concrete vault located on waterward apex.

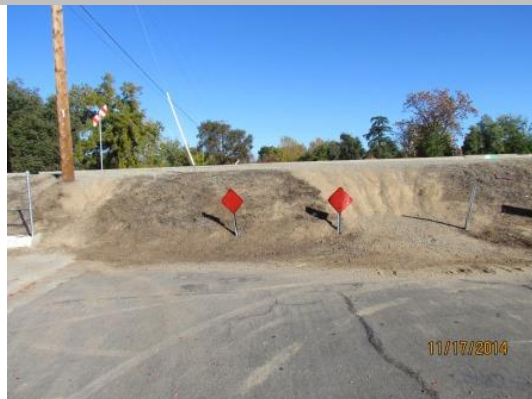
Photo 1 of 1 : SP\_2020\_NA0001\_51\_54\_20200302\_00031.jpg

LM Start	1.58	Rating **	A/W	Issue No.	54
LM End	1.58	Issue Type +	Ma	Location *	LS
Category	Earthen Levee			GPS Latitude/Longitude	
				Start	End
Item	Slope Stability			38.627251 °	38.627251 °
				-121.441460 °	-121.441460 °
DWR ID	DWR_NA0001_01_s_2012_54				
Comment Code					
S2 : Repair the levee slope damaged by foot traffic and prevent access where possible.					
Inspector Comment

Slope stability due to foot traffic needs to be monitored. Fall 2014

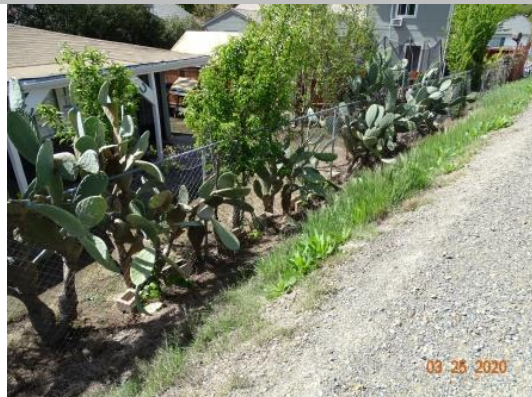
Photo 1 of 1 : SP\_2020\_NA0001\_51\_67\_20200326\_00088.jpg

LM Start	1.60	Rating **	U	Issue No.	67
LM End	1.60	Issue Type +	En	Location *	LS
Category	Earthen Levee			GPS Latitude/Longitude	
				Start	End
Item	Encroachments			38.627207 °	38.627207 °
				-121.441104 °	-121.441104 °
DWR ID	DWR_NA0001_01_f_2015_67				
Comment Code					
FE : Fence					
Inspector Comment					
A fence, fruit trees, and various cactus plants are at the LS toe. Cactus plants have grown through the fence and over the slope.

View of the chainlink fence and cactus plants along the landside levee toe. Spring 2020

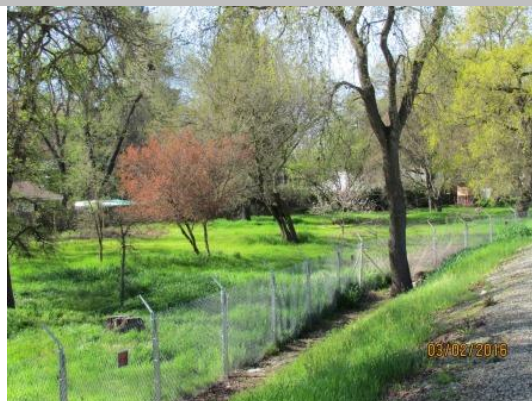
Photo 1 of 1 : SP\_2020\_NA0001\_51\_66\_20200302\_00037.jpg

LM Start	1.61	Rating **	M	Issue No.	66
LM End	1.68	Issue Type +	En	Location *	LS
Category	Earthen Levee			GPS Latitude/Longitude	
				Start	End
Item	Encroachments			38.627195 °	38.627500 °
				-121.440974 °	-121.439766 °
DWR ID	DWR_NA0001_01_f_2015_66				
Comment Code					
FE : Fence					
Inspector Comment					
A fence is at the landside levee toe.

View of the fence at the landside levee toe.

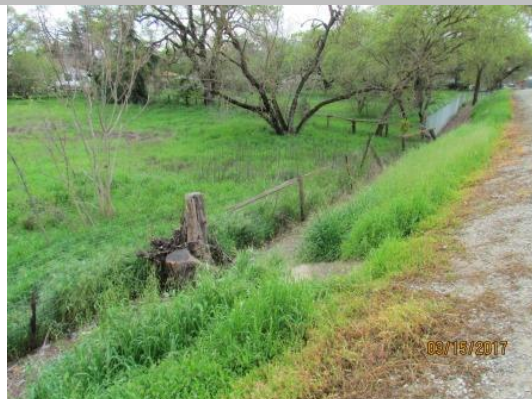
Photo 1 of 1 : SP\_2020\_NA0001\_51\_74\_20200302\_00042.jpg

LM Start	1.69	Rating **	N	Issue No.	74
LM End	1.69	Issue Type +	Ma	Location *	LS
Category	Earthen Levee			GPS Latitude/Longitude	
				Start	End
Item	Trim / Thin Trees			38.627607 °	38.627607 °
				-121.439545 °	-121.439545 °
DWR ID	DWR_NA0001_01_s_2017_74				
Comment Code					
T5 : Tree stumps.					
Inspector Comment					
There is a 24-inch large tree stump at the levee toe.

View of the tree stump at the levee toe.

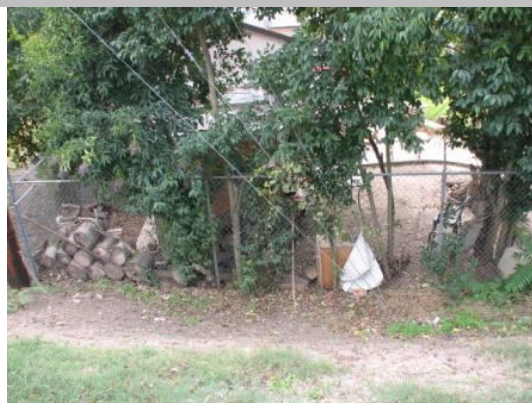
Photo 1 of 1 : SP\_2020\_NA0001\_51\_33\_20200302\_00023.jpg

LM Start	1.83	Rating **	U	Issue No.	33
LM End	1.83	Issue Type +	En	Location *	LS
Category	Earthen Levee			GPS Latitude/Longitude	
				Start	End
Item	Encroachments			38.627897 °	38.627897 °
				-121.437073 °	-121.437073 °
DWR ID	DWR_NA0001_01_s_2012_33				
Comment Code					
BU : Building					
Inspector Comment					
A wooden animal pen is built against the levee slope.

11/17/2011 Wooden structure is built within 15' of the levee toe.

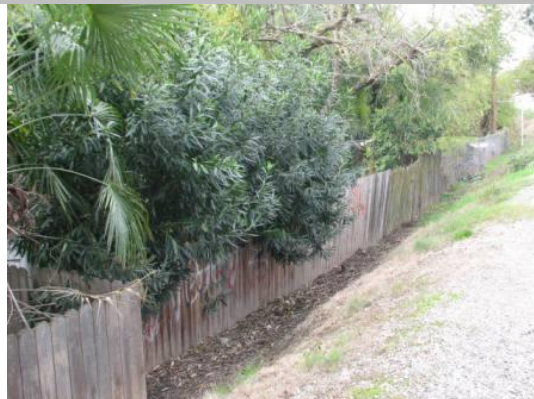
Photo 1 of 1 : SP\_2020\_NA0001\_51\_6\_20200302\_00005.jpg

LM Start	1.90	Rating **	U	Issue No.	6
LM End	1.90	Issue Type +	En	Location *	LS
Category	Earthen Levee			GPS Latitude/Longitude	
				Start	End
Item	Encroachments			38.627725 °	38.627725 °
				-121.435715 °	-121.435715 °
DWR ID	DWR_NA0001_01_s_2012_6				
Comment Code					
FE : Fence					
Inspector Comment					
A dog-eared wooden fence is built within 10-ft of the levee slope.

11/17/2011 Wooden privacy fence built at the levee toe.

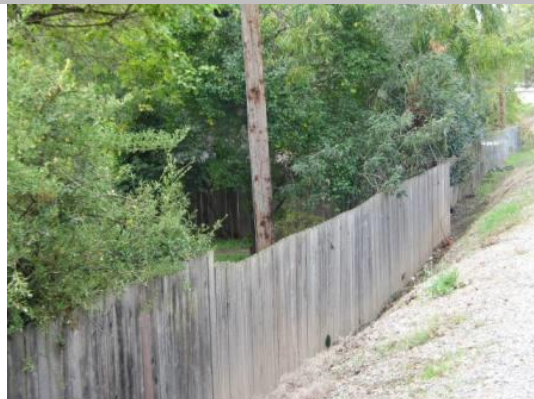
Photo 1 of 1 : SP\_2020\_NA0001\_51\_5\_20200302\_00004.jpg

LM Start	1.91	Rating **	U	Issue No.	5
LM End	1.91	Issue Type +	En	Location *	LS
Category	Earthen Levee			GPS Latitude/Longitude	
				Start	End
Item	Encroachments			38.627680 °	38.627680 °
				-121.435555 °	-121.435555 °
DWR ID	DWR_NA0001_01_s_2012_5				
Comment Code					
FE : Fence					
Inspector Comment					
A wooden fence is built within 10-ft of the levee slope.

11/17/2011 Wooden privacy fence built at the levee toe.

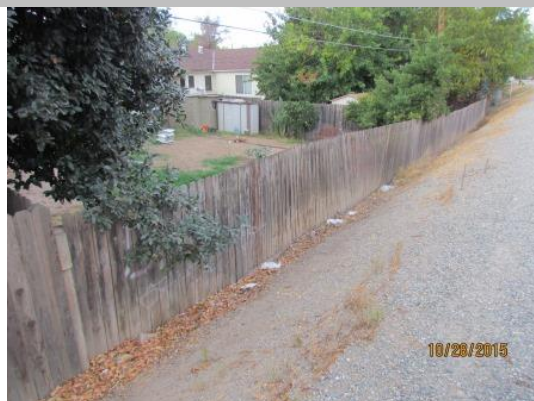
Photo 1 of 1 : SP\_2020\_NA0001\_51\_4\_20200302\_00003.jpg

LM Start	1.92	Rating **	U	Issue No.	4
LM End	1.92	Issue Type +	En	Location *	LS
Category	Earthen Levee			GPS Latitude/Longitude	
				Start	End
Item	Encroachments			38.627715 °	38.627715 °
				-121.435452 °	-121.435452 °
DWR ID	DWR_NA0001_01_s_2012_4				
Comment Code					
FE : Fence					
Inspector Comment					
A wooden fence and landscaping completely block visibility.

View of the wooden fence at the landside levee toe. Fall 2015

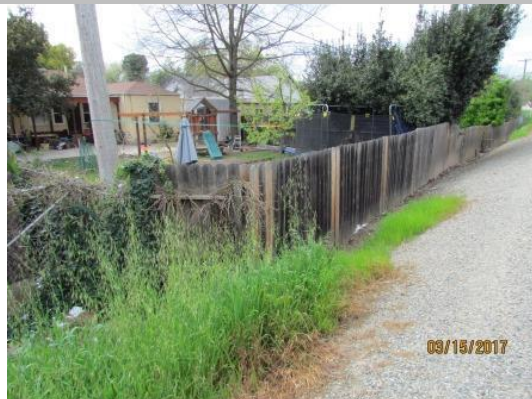
Photo 1 of 1 : SP\_2020\_NA0001\_51\_3\_20200302\_00002.jpg

LM Start	1.93	Rating **	U	Issue No.	3
LM End	1.93	Issue Type +	En	Location *	LS
Category	Earthen Levee			GPS Latitude/Longitude	
				Start	End
Item	Encroachments			38.627658 °	38.627658 °
				-121.435192 °	-121.435192 °
DWR ID	DWR_NA0001_01_s_2012_3				
Comment Code					
FE : Fence					
Inspector Comment					
A dog-eared wooden fence is built against the levee slope.

View of the fence at the landside levee toe. Spring 2017

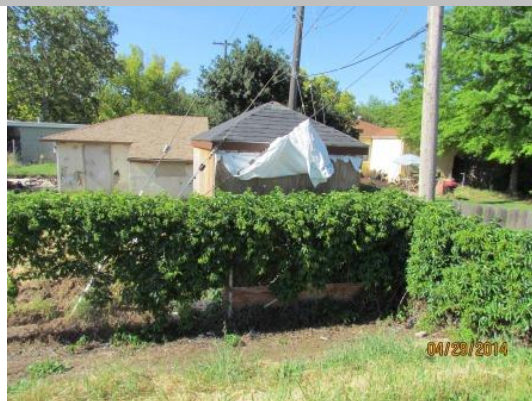
Photo 1 of 1 : SP\_2020\_NA0001\_51\_30\_20200302\_00022.jpg

LM Start	1.93	Rating **	U	Issue No.	30
LM End	1.93	Issue Type +	En	Location *	LS
Category	Earthen Levee			GPS Latitude/Longitude	
				Start	End
Item	Encroachments			38.627646 °	38.627646 °
				-121.435151 °	-121.435151 °
DWR ID	DWR_NA0001_01_s_2019_30				
Comment Code					
BU : Building					
Inspector Comment					
A wooden frame structure is within 15-ft of the levee toe.

Building on concrete pad within 15 feet of the landside levee toe.

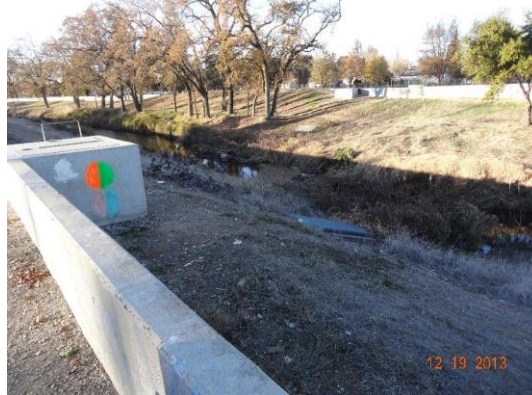
Photo 1 of 3 : UCIP\_SP\_2020\_41549\_57087.jpg

01/29/14 approximate alignment of crossings was provided by the City of Sacramento for known crossings through levee. Unable to confirm last inspection. Also City records indicate 10-inch not 15-inch--need to clarify with owner. Crossing is operational. (DWR UCIP - O. Magana)  
FIELD\_STRUCT\_DESC: 15-inch drainage pipe of unknown material through the levee, 8.5 feet below the crown. Flap gate is located on the waterside (WS) end. (no permit has been identified authorizing this structure, structure is owned by the City of Sacramento) [Additional Reference(s): DWR Levee Log, 2002]  
FS Date: 12/19/2013

View of waterward side--concrete vault and u-shape concrete headwall with debris screen.

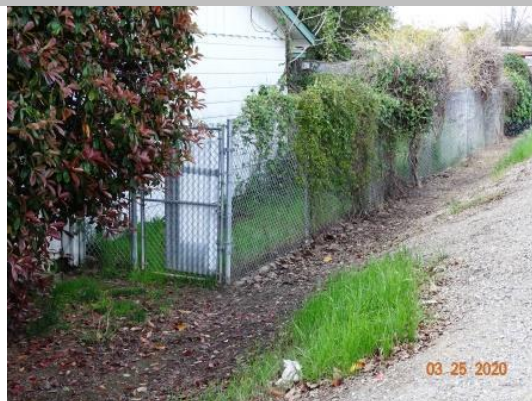
Photo 1 of 1 : SP\_2020\_NA0001\_51\_1\_20200326\_00083.jpg

LM Start	1.99	Rating **	M	Issue No.	1
LM End	1.99	Issue Type +	En	Location *	LS
Category	Earthen Levee			GPS Latitude/Longitude	
				Start	End
Item	Vegetation			38.627318 °	38.627318 °
				-121.434208 °	-121.434208 °
DWR ID	DWR_NA0001_01_s_2012_1				
Comment Code					
V6 : Landscaping					
Inspector Comment					
The chainlink fence and vines are located at the landside toe.

View of the chainlink fence and landscaping at the landside levee toe.  
Spring 2020

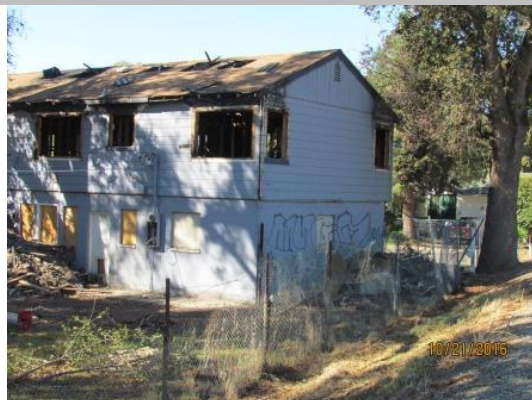
Photo 1 of 1 : SP\_2020\_NA0001\_51\_29\_20200302\_00021.jpg

LM Start	2.02	Rating **	U	Issue No.	29
LM End	2.02	Issue Type +	En	Location *	LS
Category	Earthen Levee			GPS Latitude/Longitude	
				Start	End
Item	Encroachments			38.627292 °	38.627292 °
				-121.433709 °	-121.433709 °
DWR ID	DWR_NA0001_01_s_2012_29				
Comment Code					
BU : Building					
Inspector Comment					
A two-story home foundation and chainlink fence are within 10-ft of the levee toe.

Building foundation is within 15' of the levee toe. Fall 2016

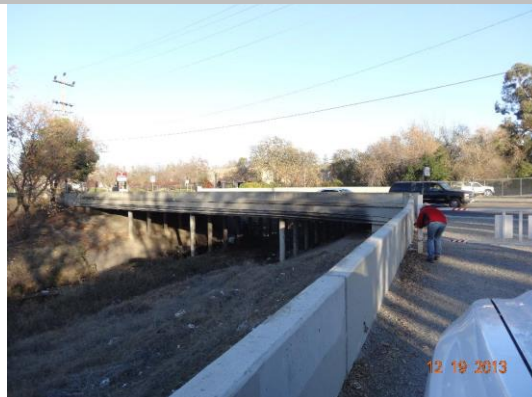
Photo 1 of 3 : UCIP\_SP\_2020\_31185\_57091.jpg

Overview markers located on bridge and floodwall indicating crossing through levee.

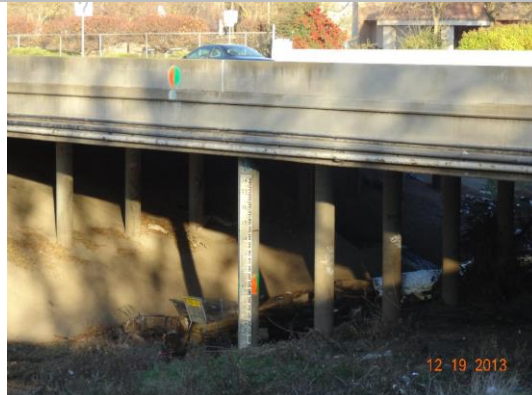
Photo 2 of 3 : UCIP\_SP\_2020\_31185\_57090.jpg

Markers visible of crossing on bridge.

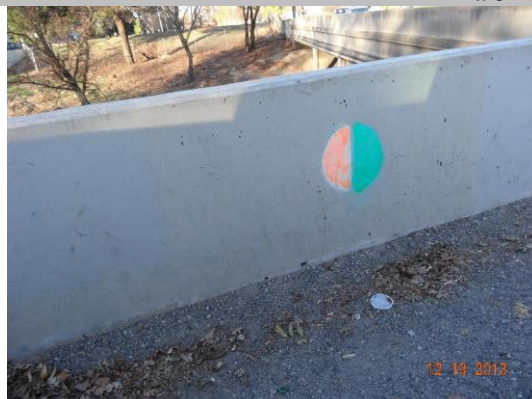
Photo 3 of 3 : UCIP\_SP\_2020\_31185\_57089.jpg

Marker of crossing on floodwall indicating crossing through levee.

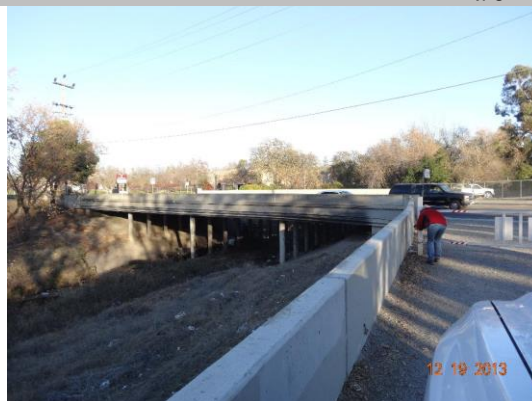
Photo 1 of 2 : UCIP\_SP\_2020\_31424\_57481.jpg

DS\_ID:24797  
 FS\_ID:31424  
 EP\_NO: N/A  
 Repair Type: Non-Urgent  
 Crossing Status: Found  
 UCIP Comments: no permit--need to determine additional information and owner of crossings.  
 FIELD\_STRUCT\_DESC: one 4-inch conduit and one 2-inch communication cable through levee at an unknown depth below the crown. Conduits are suspended through waterway and attached to downstream face of bridge.  
 FS Date: 12/19/2013

View of waterward side--conduits visible on bridge face.

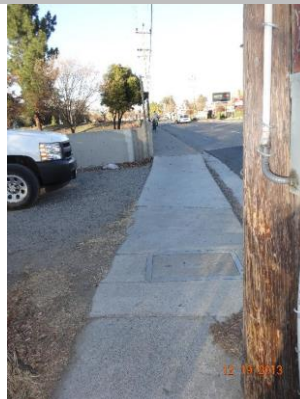
Photo 2 of 2 : UCIP\_SP\_2020\_31424\_57480.jpg

Service box located on sidewalk unable to determine if box belongs to conduits.

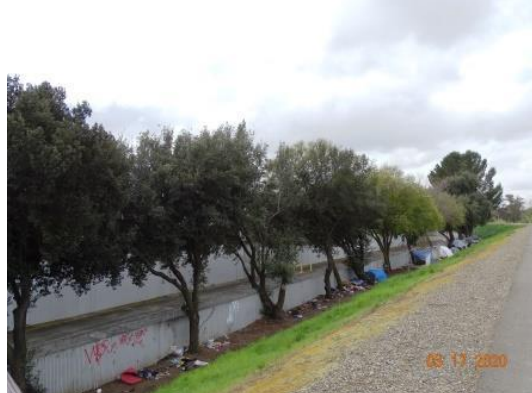
Photo 1 of 1 : SP\_2020\_NA0001\_52\_12\_20200319\_00029.jpg

LM Start	0.00	Rating **	U	Issue No.	12
LM End	0.14	Issue Type +	En	Location *	LS
Category	Earthen Levee			GPS Latitude/Longitude	
				Start	End
Item	Encroachments			38.602823 °	38.604168 °
				-121.472670 °	-121.470862 °
DWR ID	DWR_NA0001_02_s_2020_12				
Comment Code					
DE : Debris					
Inspector Comment					
Camps are located at the landside levee toe.

View of camps along the landside levee toe. Spring 2020

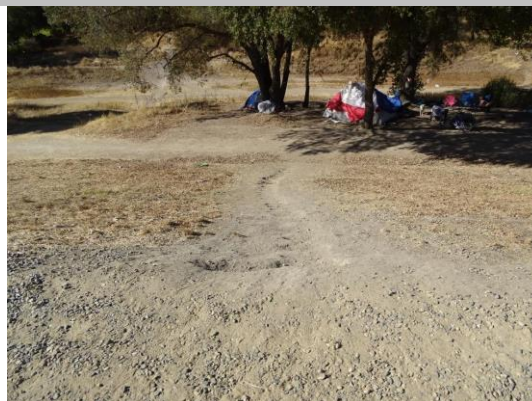
Photo 1 of 1 : SP\_2020\_NA0001\_52\_39\_20200302\_00002.jpg

LM Start	0.17	Rating **	A/W	Issue No.	39
LM End	0.17	Issue Type +	Ma	Location *	WS
Category	Earthen Levee			GPS Latitude/Longitude	
				Start	End
Item	Slope Stability			38.604455 °	38.604455 °
				-121.470417 °	-121.470417 °
DWR ID	DWR_NA0001_02_f _ 2018_39				
Comment Code					
S2 : Repair the levee slope damaged by foot traffic and prevent access where possible.					
Inspector Comment					
Monitor the footpath on the waterside slope.

View of stair steps dug into levee slope. Fall 2018

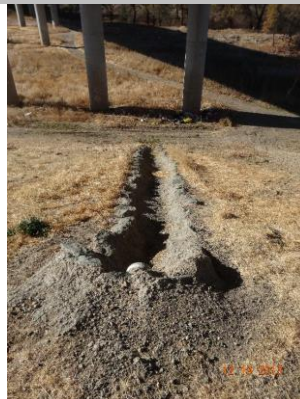
Photo 1 of 3 : UCIP\_SP\_2020\_31443\_57484.jpg

DS\_ID:24798  
FS\_ID:31443  
EP\_NO: N/A  
Repair Type: Non-Urgent  
Crossing Status: Indicator Found  
UCIP Comments: 08/16/2017 DWR Deferred Maintenance Project (DMP), Vince Rodriguez, forwarded email received from Tim Kerr, General Manager of American River Flood Control District (ARFCD) with file "DWR Eligible Pipes Found in ARFCD" from ARFCD that shows the ownership and location of the pipes Tim Kerr investigated. No owner was identified, ARFCD Staff Notes indicate 4-inch HDPE under Arden-Garden Connector. (DWR UCIP - O. Magana) 12/06/2013 no permit (unauthorize crossing)--need to determine additional information about crossing. Unable to determine if pipe crosses levee. (DWR UCIP - O. Magana)  
FIELD\_STRUCT\_DESC: 4-inch high density polyethylene (HDPE) pipe through levee at unknown depth. (no permit has been identified authorizing this crossing, owner has not been identified)  
FS Date: 12/6/2013

View of waterward slope.

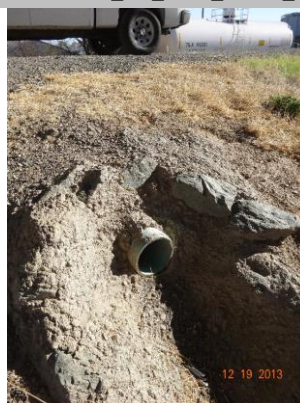
Photo 2 of 3 : UCIP\_SP\_2020\_31443\_57483.jpg

View of pipe through levee.

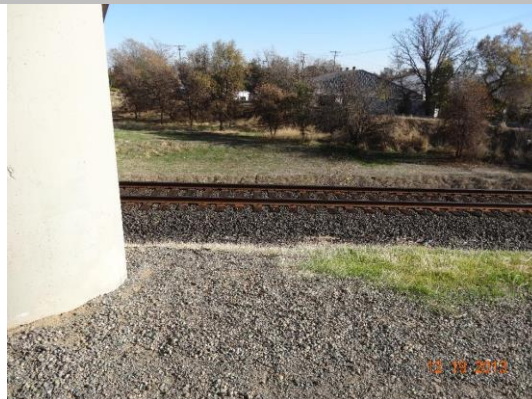
Photo 3 of 3 : UCIP\_SP\_2020\_31443\_57482.jpg

View of landward side.

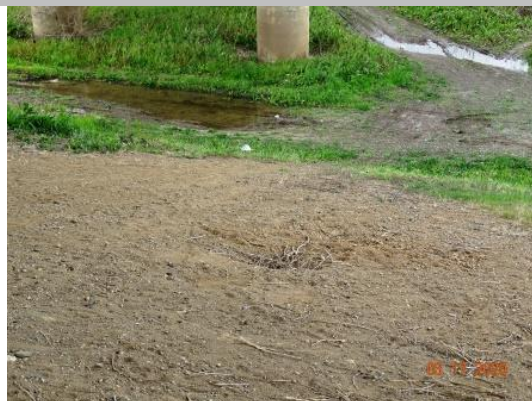
Photo 1 of 1 : SP\_2020\_NA0001\_52\_14\_20200319\_00032.jpg

LM Start	0.37	Rating **	M	Issue No.	14
LM End	0.37	Issue Type +	Ma	Location *	WS
Category	Earthen Levee			GPS Latitude/Longitude	
				Start	End
Item	Animal Control			38.606420 °	38.606420 °
				-121.468050 °	-121.468050 °
DWR ID	DWR_NA0001_02_s_2020_14				
Comment Code					
A3 : No rodents visible, but rodent burrows visible; need to backfill and compact or grout burrows.					
Inspector Comment					
Backfill a large hole on the waterside slope.

View of a large hole on the waterside slope underneath the overpass.  
Spring 2020

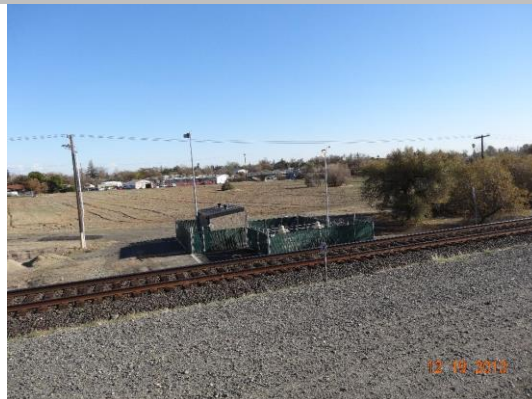
Photo 1 of 3 : UCIP\_SP\_2020\_49533\_55042.jpg

Comment Code					
Inspector Comment					
DS_ID:24274 FS_ID:49533 EP_NO: 6064 Repair Type: Non-Urgent Crossing Status: Found UCIP Comments: 08/29/2016 Facility details confirmed by the City of Sacramento only one 36-inch WSP goes through levee at this location. Ownership in the CVFPB records still shows ARFCD. Efforts to update CVFPB records are in-progress, owner of this facility is the City of Sacramento. Need to coordinate with ARFCD and City of Sacramento to determine the fate of Pump Station 3. (DWR UCIP - Olivia M)12/19/2013 Need to determine the status of crossing. Unable to confirm if crossing found in field corresponds to this entry. FIELD_STRUCT_DESC: [Sump No. 153] 36-inch welded steel drainage pipe (WSP) with 15/32-inch wall thickness through the levee, 5.2 feet below the crown. Corrugated metal (CM) cutoff wall around pipe between center and waterside (WS) shoulder. Siphon breaker in concrete box on WS slope. 36-inch pipe connects, past LS toe, through header 2-30 inch WSP and 1-12 inch WSP at this facility. Pump station located on landside (LS). Concrete "U" headwall and flap gate are located on the WS end. Rock revetment on WS slope. On March 28, 1995, the Sacramento City Council adopted Resolution No. 95-123 authorizing the execution of Agreement No. 95-065 regarding the transfer of drainage facilities that include Pump Station 3 as described by ARFCD and described by the City of Sacramento as Sump 153. Pump Station 3 was replaced by Sump 3. (36-inch pipe installed under Permit No. 6064 and 6064-A, 1968 - American River Flood Control District [ARFCD]) [Additional Reference (s): DWR Levee Log, 2002, City of Sacramento D 151-159_CC1995-95-062_Transfer of Drainage Sumps to City from ARFCD, and City of Sacramento Sump 153 Plan and Profile] FS Date: 12/19/2013

View of landward side--pump station with multiple pumps.

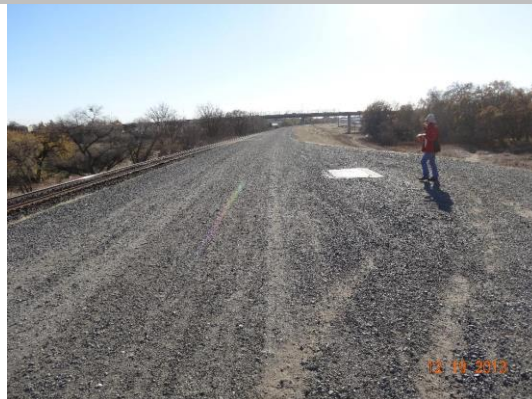
Photo 2 of 3 : UCIP\_SP\_2020\_49533\_55041.jpg

Vault located on levee crown.

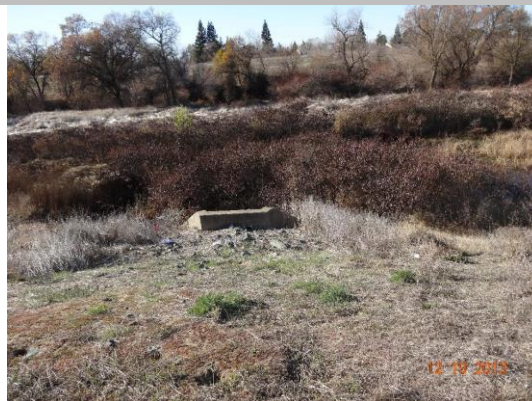
Photo 3 of 3 : UCIP\_SP\_2020\_49533\_55040.jpg

Concrete headwall visible on waterward side.

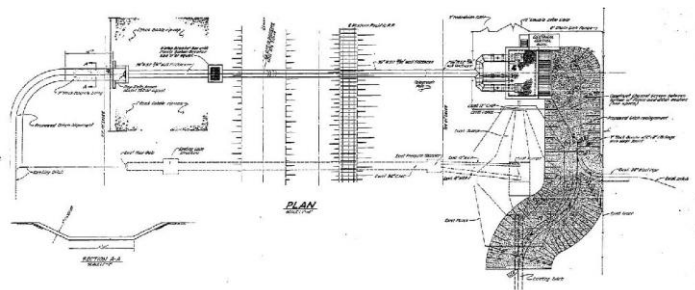
Photo 2 of 2 : UCIP\_SP\_2020\_51428\_75578.jpg

Sump 153 Plan and Profile, existing Pump Plant No. 3 referenced.

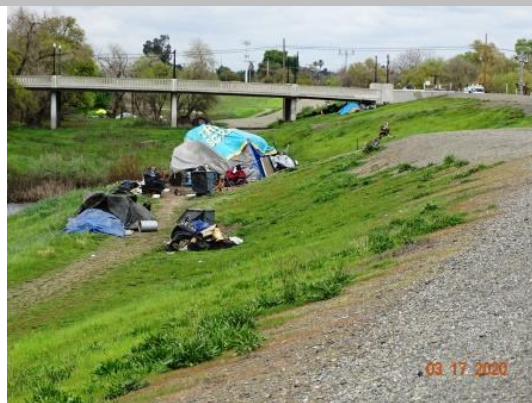
Photo 1 of 1 : SP\_2020\_NA0001\_52\_10\_20200319\_00033.jpg

LM Start	0.56	Rating **	U	Issue No.	10
LM End	0.56	Issue Type +	En	Location *	WS
Category	Earthen Levee			GPS Latitude/Longitude	
				Start	End
Item	Encroachments			38.609013 °	38.609013 °
				-121.466800 °	-121.466800 °
DWR ID	DWR_NA0001_02_s_2020_10				
Comment Code					
DE : Debris					
Inspector Comment					
Three tents are located on the waterside slope.

View of camps on the waterside levee toe. Spring 2020

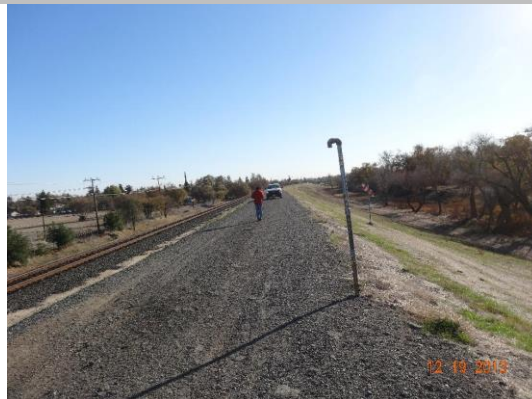
Photo 1 of 3 : UCIP\_SP\_2020\_52679\_52766.jpg

Comment Code					
Inspector Comment					
DS_ID:24277 FS_ID:52679 EP_NO: 2333 Repair Type: Non-Urgent Crossing Status: Indicator Found UCIP Comments: 11/3/2014 Need to contact owner to determine status of crossing. Priority under Part IX has been changed from Urgent to Non-Urgent as a measure to normalize the data. Markers present however unable to confirm pipe size. Recommend LMA to contact owner to determine additional information details--confirm pipe size, alignment, and last inspection completed confirming integrity of crossing. (DWR UCIP - O. Magana) 12/19/2013 Need to contact owner to determine status of crossing. Unable to confirm if indicators visible on levee crown and landward side correspond to this crossing. (DWR UCIP - O. Magana) FIELD_STRUCT_DESC: *ABANDONED* 12-inch gas line of unknown material through the levee, 3 feet below the crown. Abandoned by grouting in 2002. In case of an emergency related to this pipeline, PG&E has identified the following contacts: PG&E's local pipeline engineer, Mike Aronoff at 916-307-9472 (cell), and Gas Control (north) at 800-442-4743. For non-emergency issues, please contact the local PG&E Gas Pipeline Operations and Maintenance (GPOM) supervisors for the Sacramento region, David Wade at 209-639-1039 (cell), or Ron Hicks at 916-396-9038 (cell). (12-inch line authorized under Permit No. 2333, 1957 - Pacific Gas and Electric Company [PG&E]) [Additional Reference(s): DWR Levee Log, 2002] FS Date: 12/19/2013

Overview of levee crown at crossings.

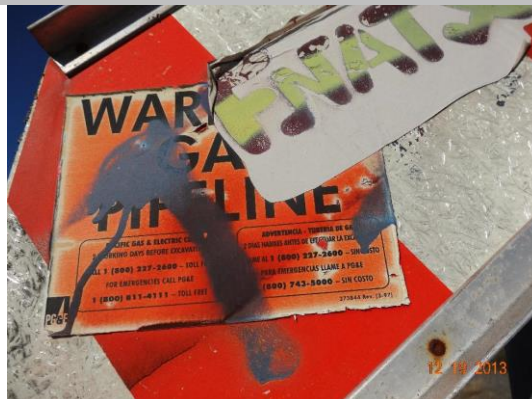
Photo 2 of 3 : UCIP\_SP\_2020\_52679\_52768.jpg

Marker with emergency contact information located on waterward slope.

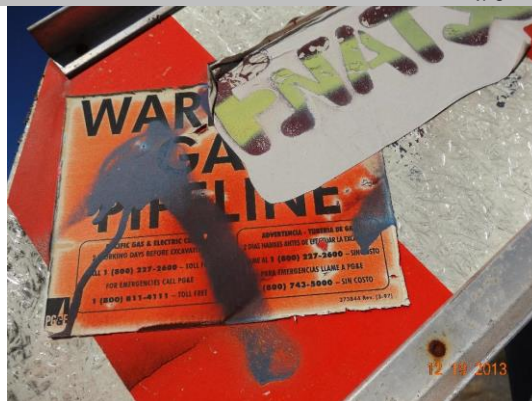
Photo 2 of 3 : UCIP\_SP\_2020\_52682\_52780.jpg

Marker with emergency contact information located on waterward slope.

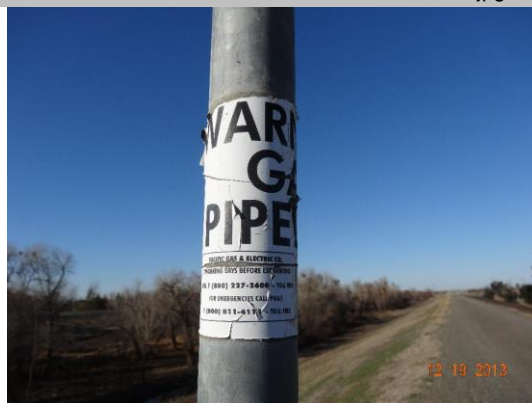
Photo 3 of 3 : UCIP\_SP\_2020\_52682\_52779.jpg

Marker located on the waterward side.

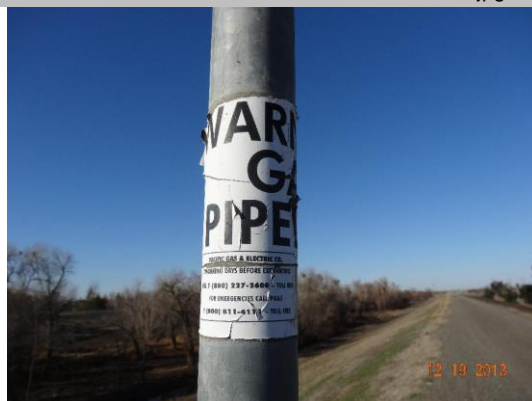
Photo 3 of 3 : UCIP\_SP\_2020\_52684\_52773.jpg

Additional marker located on waterward levee crown hinge point.

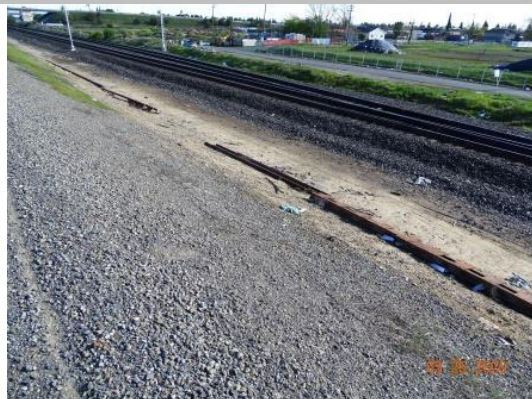
Photo 1 of 1 : SP\_2020\_NA0001\_52\_18\_20200511\_00034.jpg

LM Start	2.52	Rating **	M	Issue No.	18
LM End	2.52	Issue Type +	En	Location *	LS
Category	Earthen Levee			GPS Latitude/Longitude	
				Start	End
Item	Encroachments			38.637098 °	38.637098 °
				-121.471012 °	-121.471012 °
DWR ID	DWR_NA0001_02_s_2020_18				
Comment Code					
DE : Debris					
Inspector Comment					
Railroad rails were placed on the landside slope.

View of railroad rails at the landside levee toe. Spring 2020
